LEVEL ONE

SURVEILLANCE

AND INSPECTION REPORT

Client Name: Symon Bros. Constructions Pty Ltd
Project Name: The Grove South West Precinct Stage 51
Date: 19th of February 2024
Author: Mr. Thomas Crowe
Reference No.: 9008-036
Revision: 0
Project Manager: Mr. George Dimopoulos

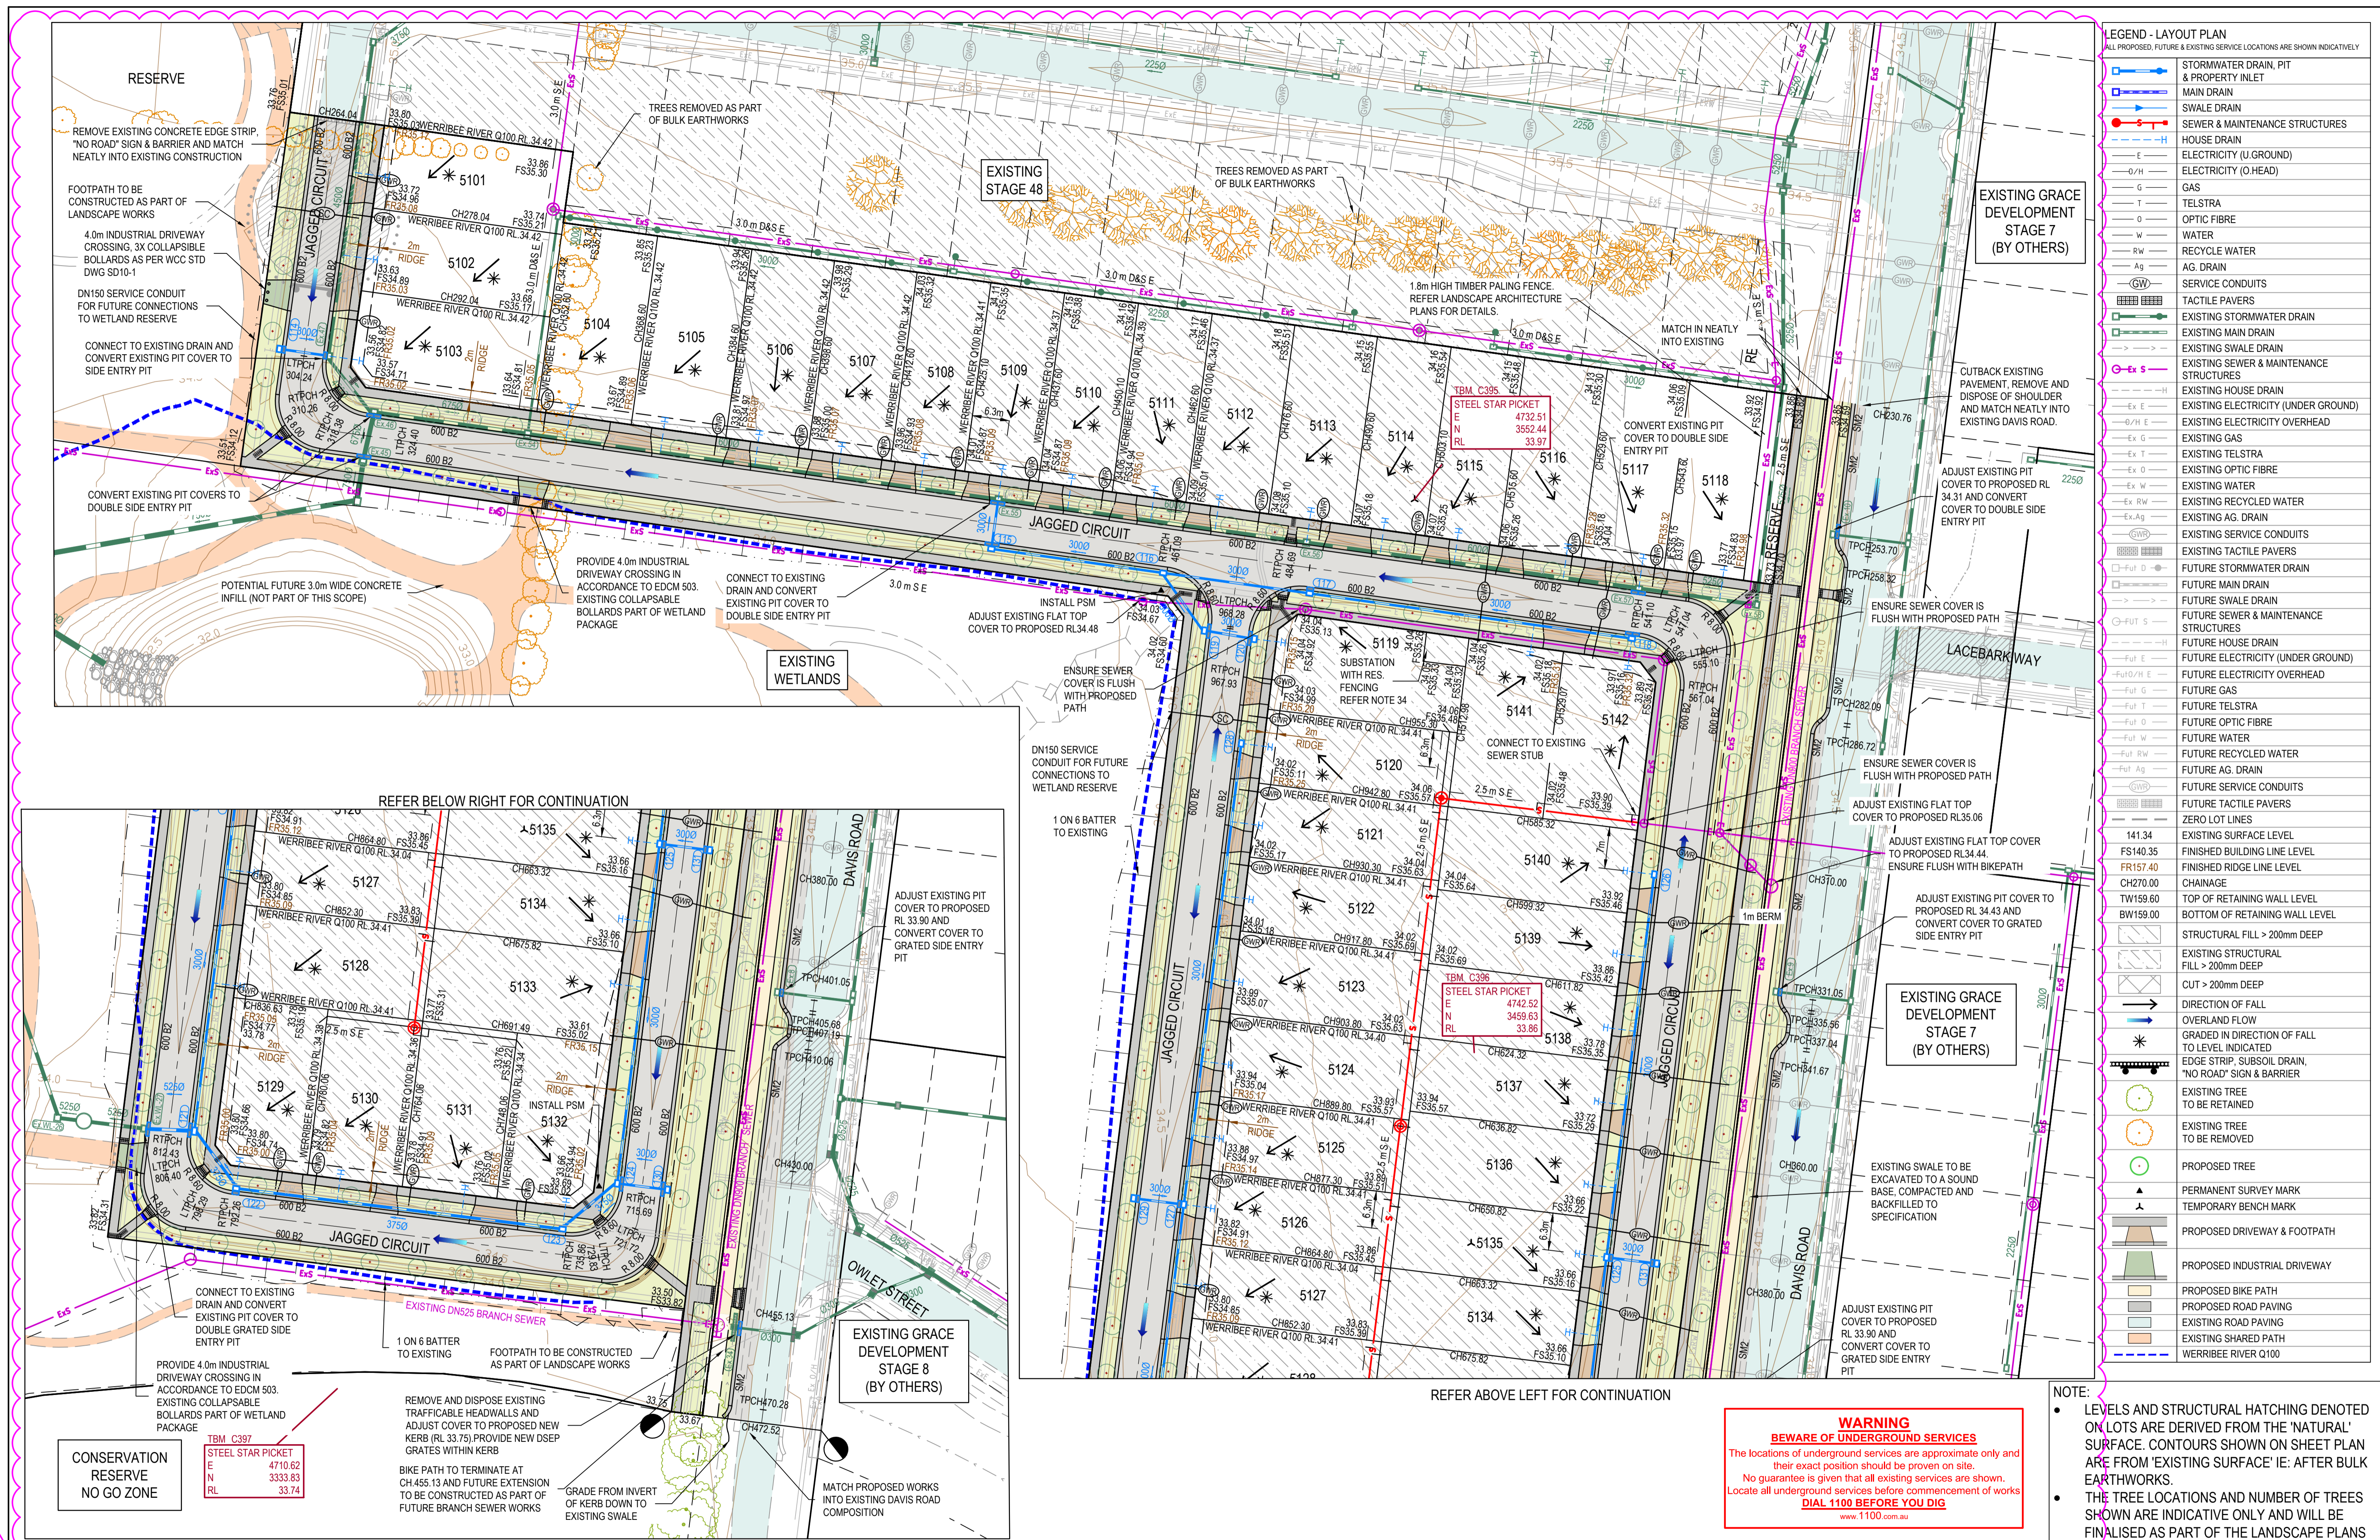
MELWAYS REF 234 F9	PROJECT / DRAWING No 2190E-051-111	SHEET No 03 of 22	REVISION 1
--------------------	------------------------------------	-------------------	------------

(1) Road & Drainage Layout Plan Drawing No. 2190E-051-111 (Rev. 1)

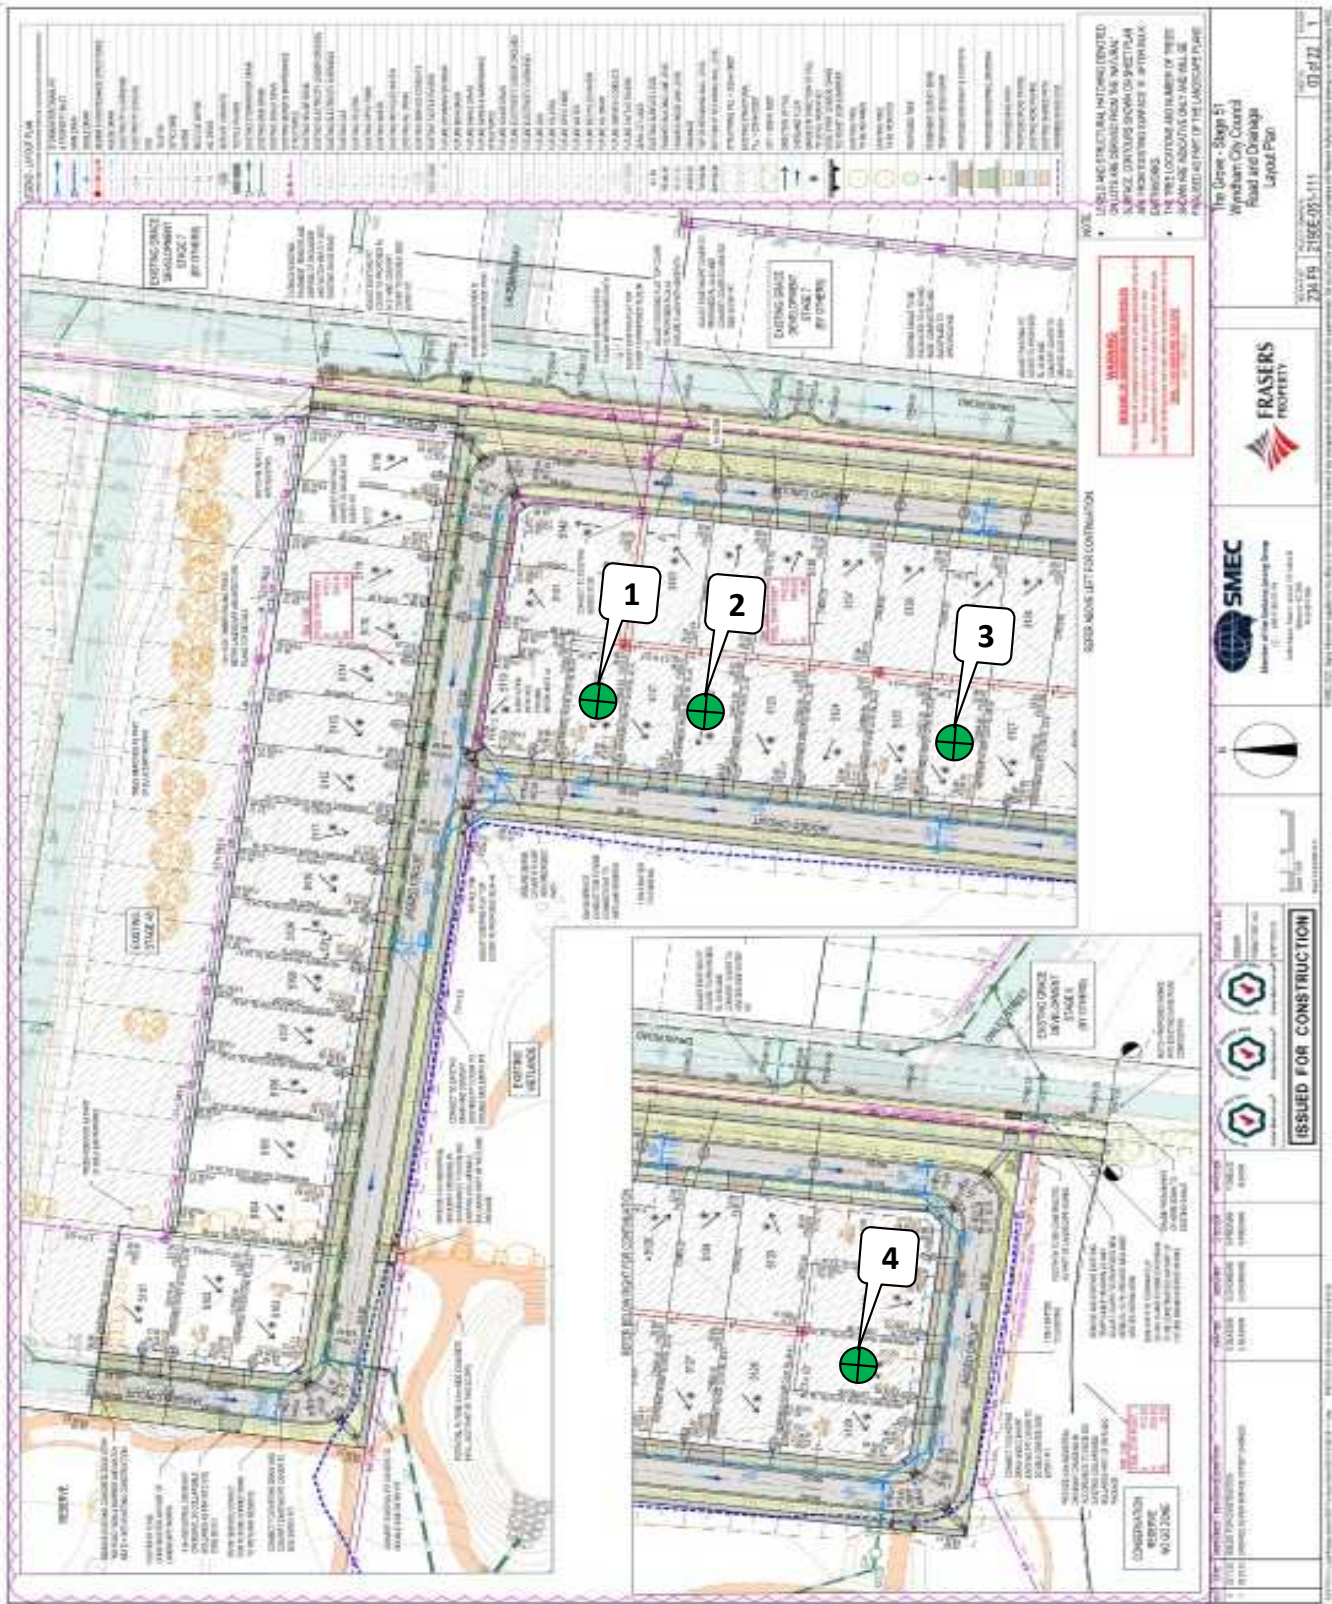
FIGURE No: 1 of 2

Sketch indicating compaction test locations
